**PRELIMINARY ASSESSMENT/
VISUAL SITE INSPECTION**

**CATERPILLAR INC.
MAPLETON, ILLINOIS
ILD 052 664 364**

FINAL REPORT

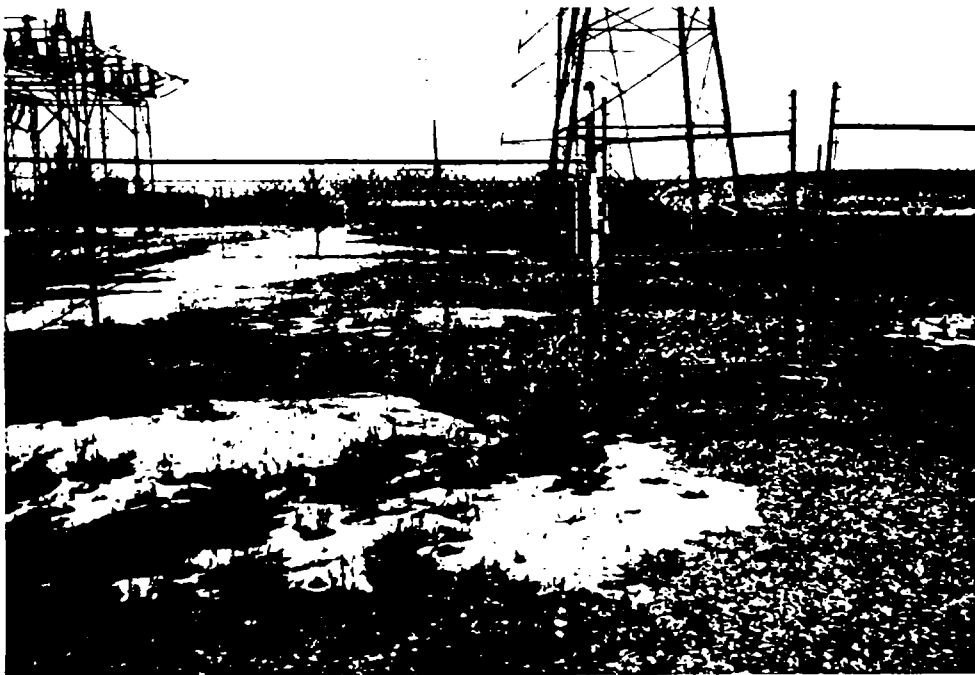
Photograph No. 2
 Orientation: East
 Description: South portion of the fenced-in area of Former Hazardous Waste Drum Storage Area.

Unit Description: The Former Hazardous Waste Drum Storage Area is surrounded by an 8-foot fence and is located south of Building Q. The area consists of an all gravel cover and occupies a space of approximately 80 feet by 80 feet. This area is no longer active (see Photograph No. 2).

Observations: There were no drums left in this area. No visual signs of release were observed.

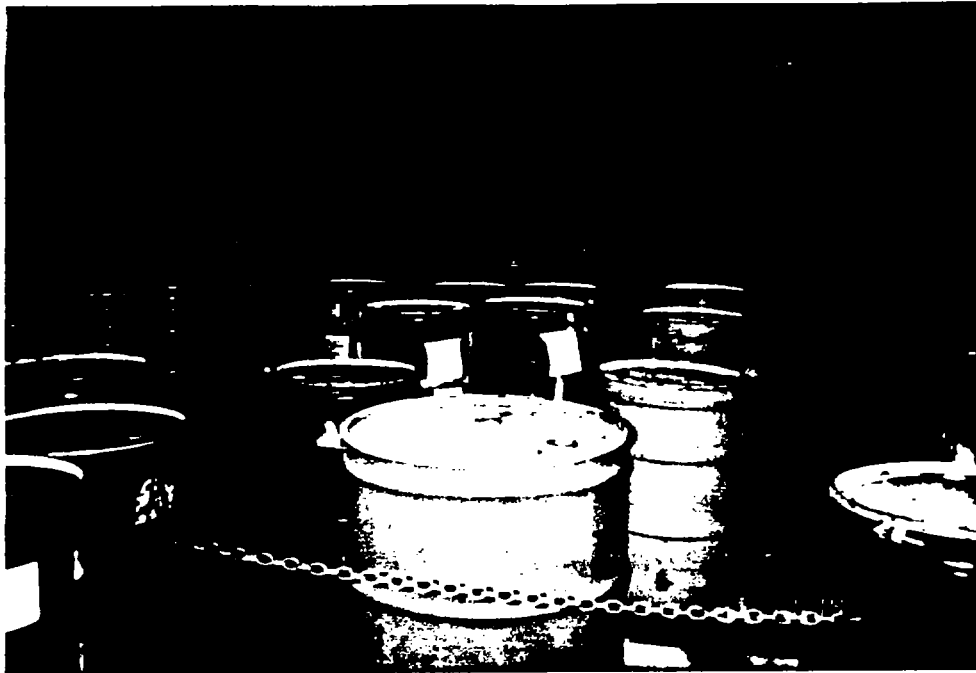
Photograph No. 3

Unit Description: The Indoor Hazardous Waste Drum Storage Area is located inside Building V. It consists of a concrete floor enclosed by two adjacent walls and a single strand chain-type fence. The area of this unit is approximate 30 feet by 60 feet. (See Photograph No. 3).

Observations: At the time of inspection, the unit contained approximately 70 drums of waste, all of which were stored on wooden skids. A brief examination of the area showed the drums containing waste grease (D008, nonhazardous), waste resin solutions (D001, D002, F002, U122, nonhazardous), waste janitorial products (D002, nonhazardous), and unused commercial pesticides. No visual signs of releases were observed.

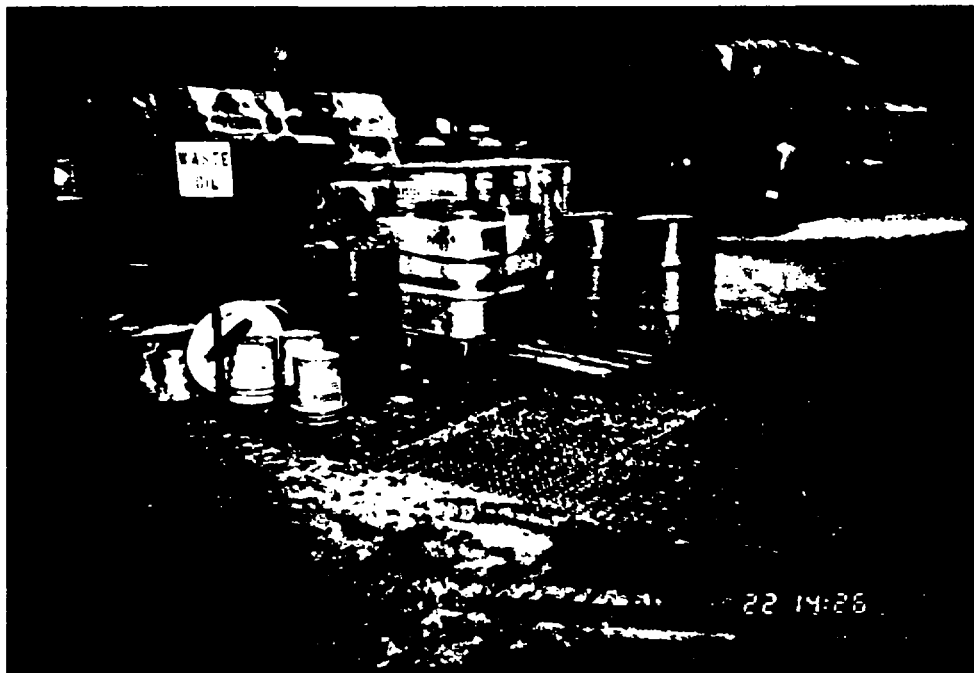
Photograph No. 4

Observations: No visual signs of release were observed in the area of the sump.

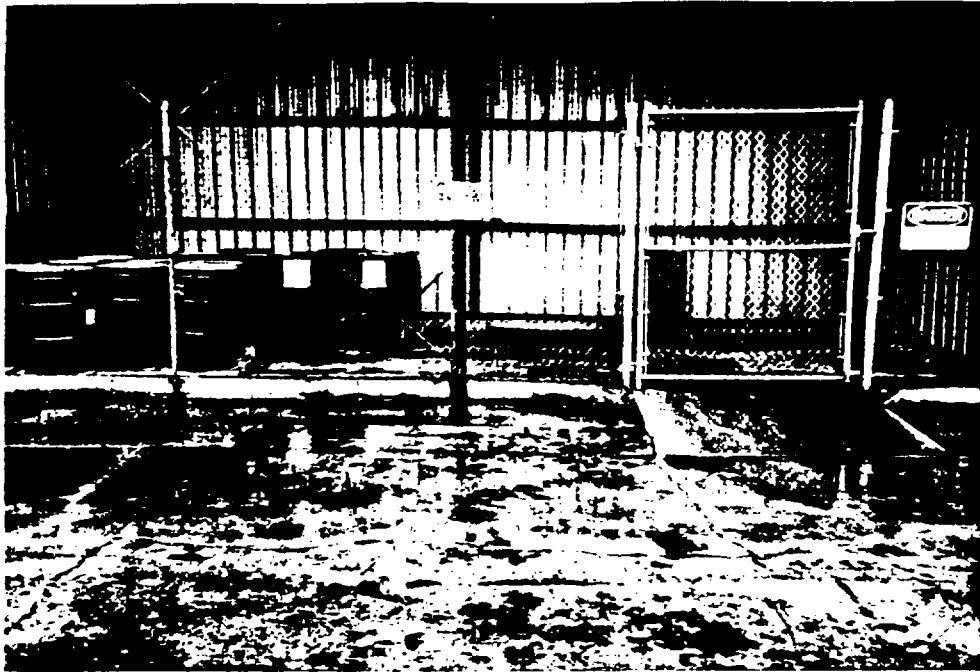
Photograph No. 5

Unit Description: The Hazardous Waste Drum Storage Area is in a separate enclosure located north of Building V. The enclosure is called Y-16. The enclosure consists of three walls and a metal roof with a cyclone-type fence on the fourth side. The enclosure occupies an area approximately 12 feet by 30 feet, on concrete. The concrete floor is encompassed by a curb about 4 inches high (see Photograph No. 5).

Observations: The unit contained approximately 15 drums at the time of the VSI. No visual signs of release were observed.

Description: Hazardous Waste Drum Storage Area showing three-sided enclosure with fenced-in front and concrete pad with curbs.

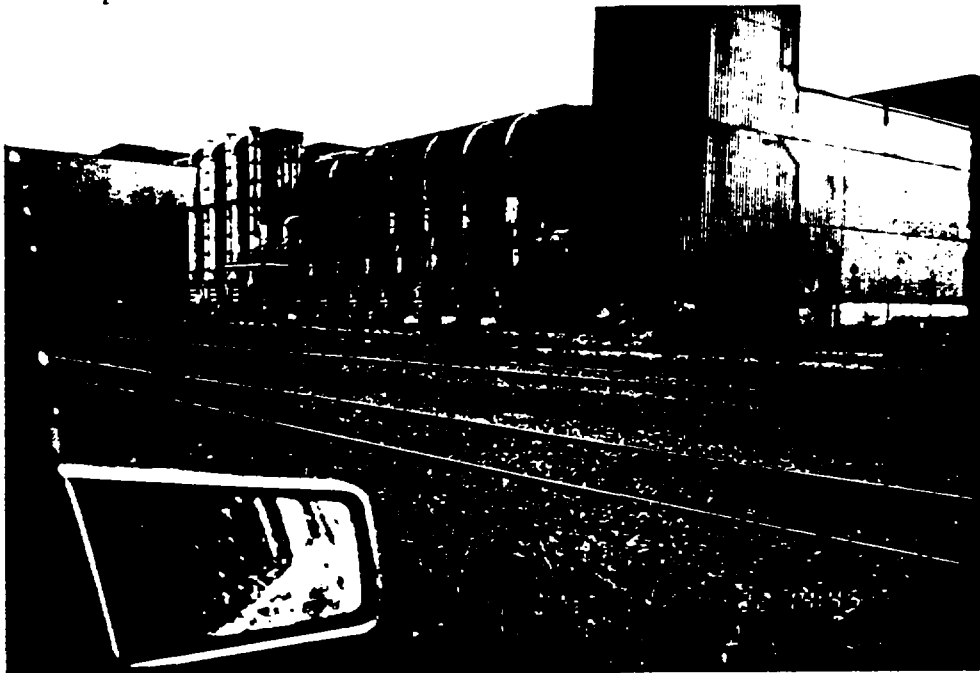
Photograph No. 6

Description: Facility Baghouse Dust Collectors on south wall of Building B.

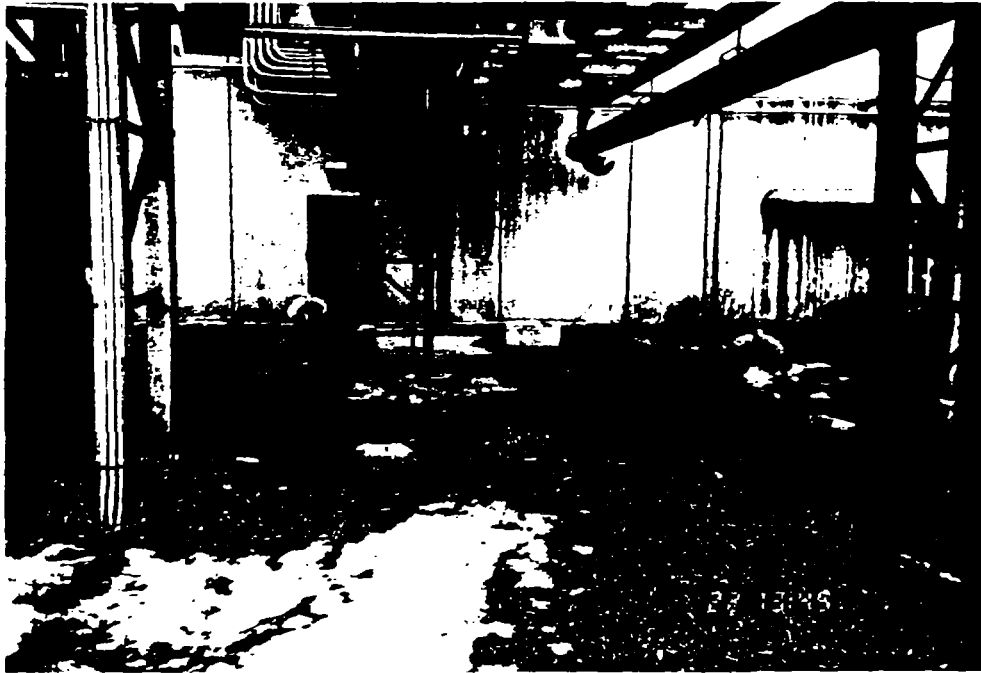
Photograph No.11
Orientation: East
Description: Location of Sulfuric Acid Leak.

On November 6, 1990, there was a sulfuric acid leak from an acid feed line for the wastewater treatment plant, outdoors of Building RR. The leak was reported to NRC on the November 7, 1990. The leak had contaminated soil in the immediate area. The maximum amount of sulfuric acid released was 2,420 pounds. Twenty-two 85-gallon drums of contaminated material were removed by Caterpillar personnel and shipped out (Caterpillar, 1993a). There is no documentation of (1) where the soil was removed, (2) sampling results to confirm that no contamination exists, or (3) IEPA approval; therefore this spill area is considered an AOC (see Photograph No. 11).

occurred as a result of overflows at the unit. Integrity tests of the tanks at AOCs 1 and 3 should be performed, and the soil around all AOCs should be sampled for contamination. RAI recommends soil sampling at SWMU 1 to determine if hazardous constituent contamination does exist. Furthermore, RAI recommends hazardous constituent analysis of the nonhazardous special wastes stored at SWMU 1. According to the facility representative, ground water monitoring at SWMU 1 has not identified any ground water contamination and the monitoring data is submitted quarterly to IEPA. RAI also recommends that a hazardous constituent waste analysis be performed on the waste dust stored in SWMU 6. If the waste is determined to be hazardous, sampling may be necessary for all environmental media. RAI recommends no further action for any of the other identified SWMUs.
